Name Of Dam: CHERRYSTONE NO. 2A  
Location: PITTSYLVANIA COUNTY, VIRGINIA  
Inventory Number: VA. NO. 14303

# PHASE I INSPECTION REPORT

## NATIONAL DAM SAFETY PROGRAM

PHASE I INSPECTION REPORT  
NATIONAL DAM SAFETY PROGRAM  
CHERRYSTONE DAM NO. 2A, VA. NO. 14303

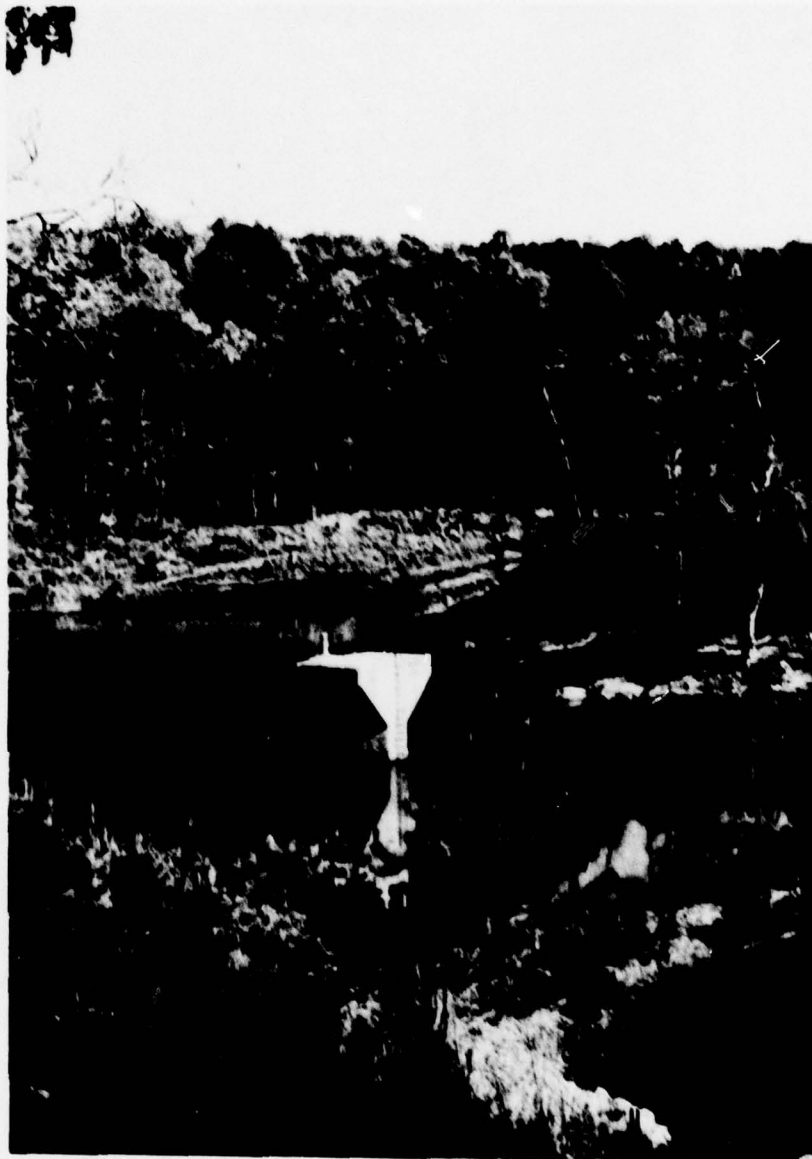
PHOTO #2

The intake structure was in good condition and no cracking or spalling was observed. The trash rack had no debris and was in good condition.

VIEW OF INTAKE STRUCTURE  
Note: Emergency Spillway Entrance in Background

The intake structure appears to be in good condition and we recommend a regular maintenance program.

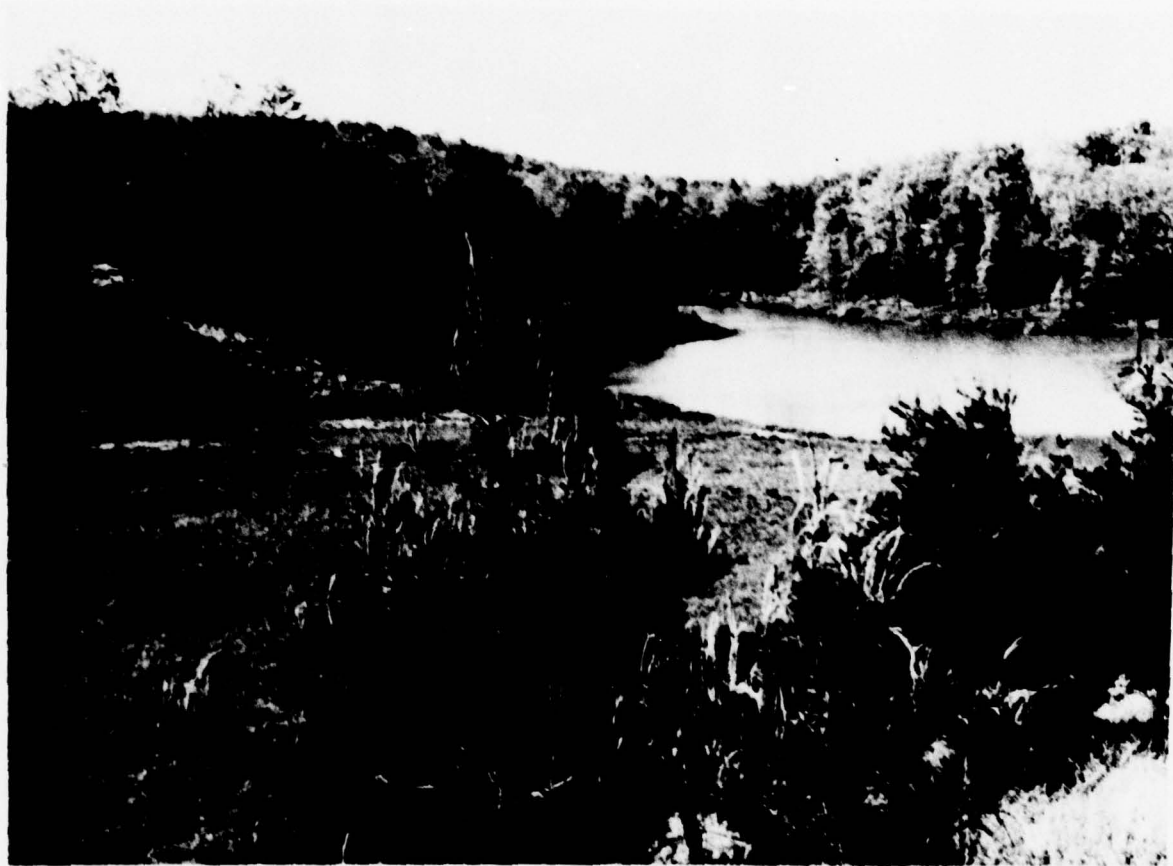
PHOTO #3

ENTRANCE TO EMERGENCY SPILLWAY

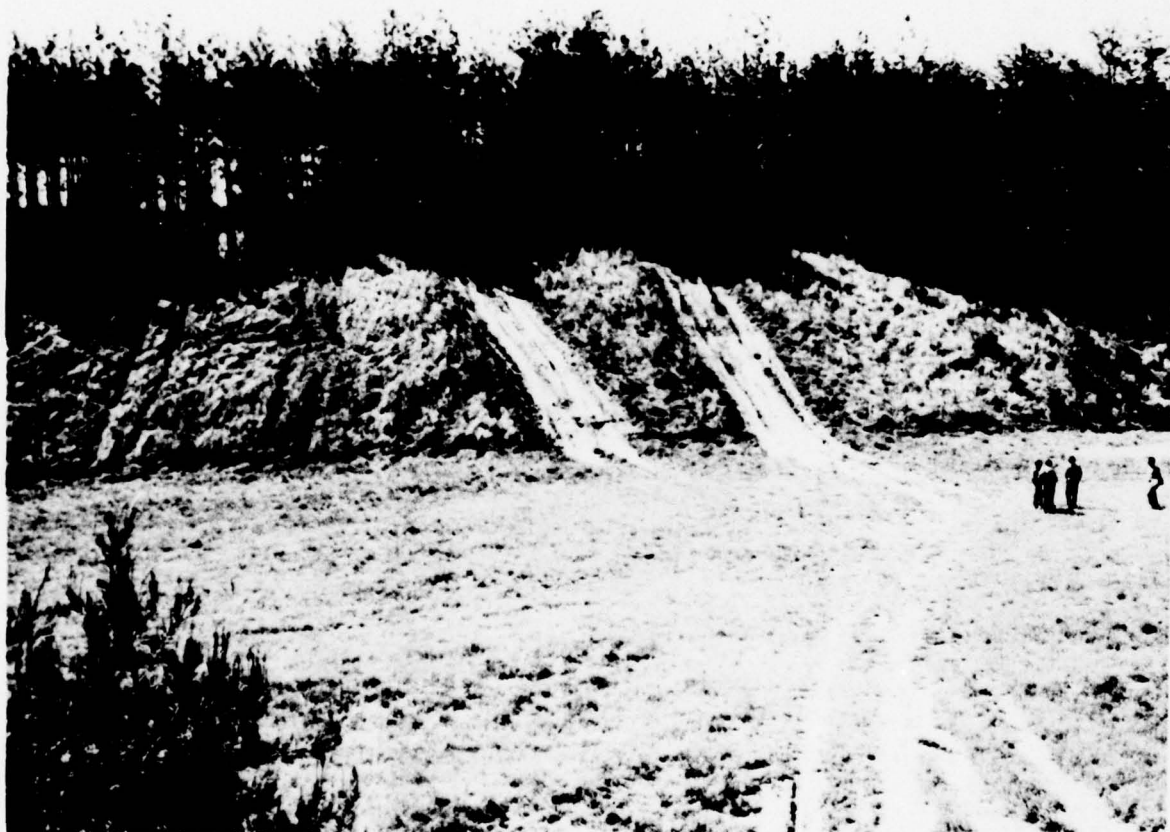
PHOTO #4

Attempts have been made to prevent the driving of four-wheel drive vehicles on the embankment. This type of vehicular activity tends to damage the embankment slopes and makes these areas more susceptible to erosion, which in turn increases the potential for slope failure. In order to insure the integrity of the dam, this vehicular traffic must be prevented.

VIEW OF VEGETATION WHICH HAS BEEN STRIPPED BY 4-WHEEL VEHICLES

1.3 Sloughing or Erosion: No sloughing or erosion was noted except for a path formed by four-wheel drive vehicles.

1.7 Seepage: A damp area exists in a track of the four-wheel drive vehicle path, approximately 20 ft left of the outlet pipe and 5.5 ft above the top of the pipe. No flow was observed from this spot.

The visual inspection revealed an immediate need to prevent the further use by four-wheel drive vehicles on the embankment. The vehicle path developed on the downstream slope should be graded and reseeded in order to diminish the potential of embankment erosion. Otherwise, there are no apparent problems and there are no immediate needs for remedial measures. The slopes, the crest of the structure, and the spillway should be mowed twice per year and small trees or saplings removed once per year. A damp area was observed in the vehicle track at the base of the downstream slope and should be inspected quarterly to detect any increase in seepage rates that may undermine the integrity of the dam.

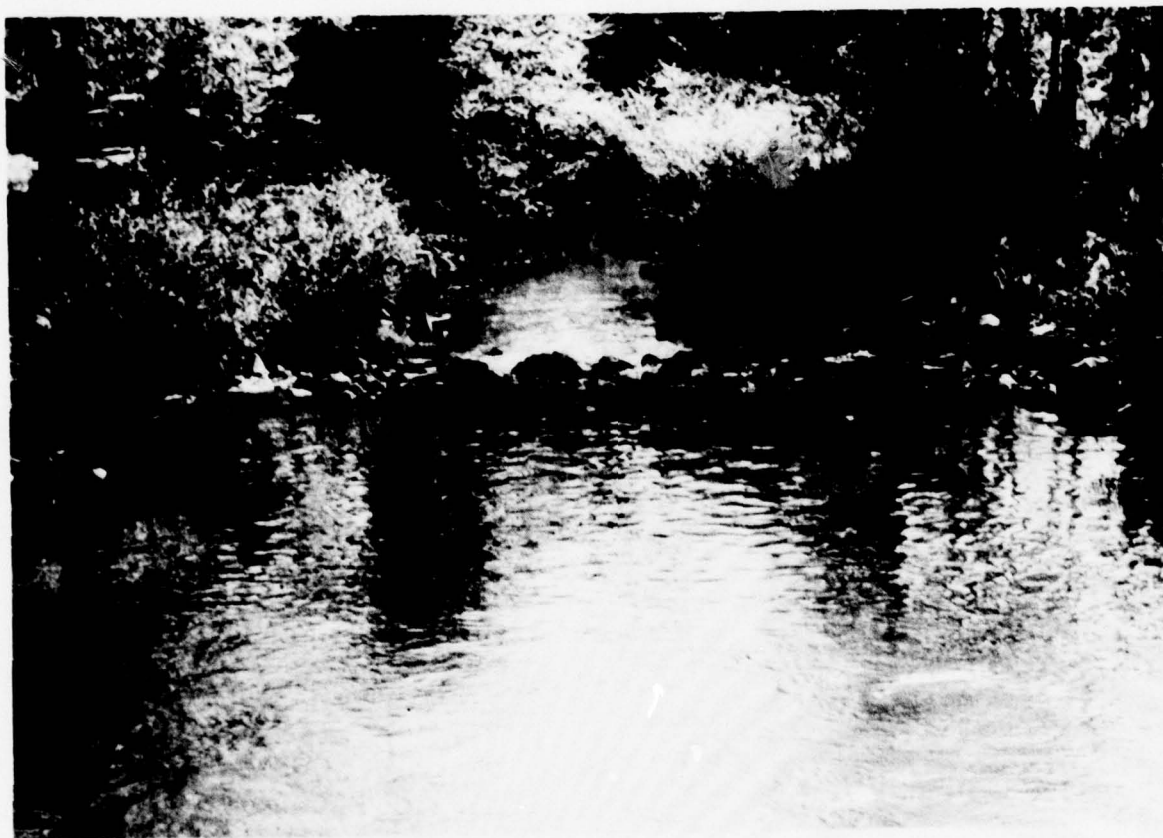
PHOTO #6

CLOSE-UP STILLING BASIN
